# Case Studies

## Guidance for Refuge Area Selection

# Xenia Senior High School

# St. Augustine Elementary School and Gymnasium

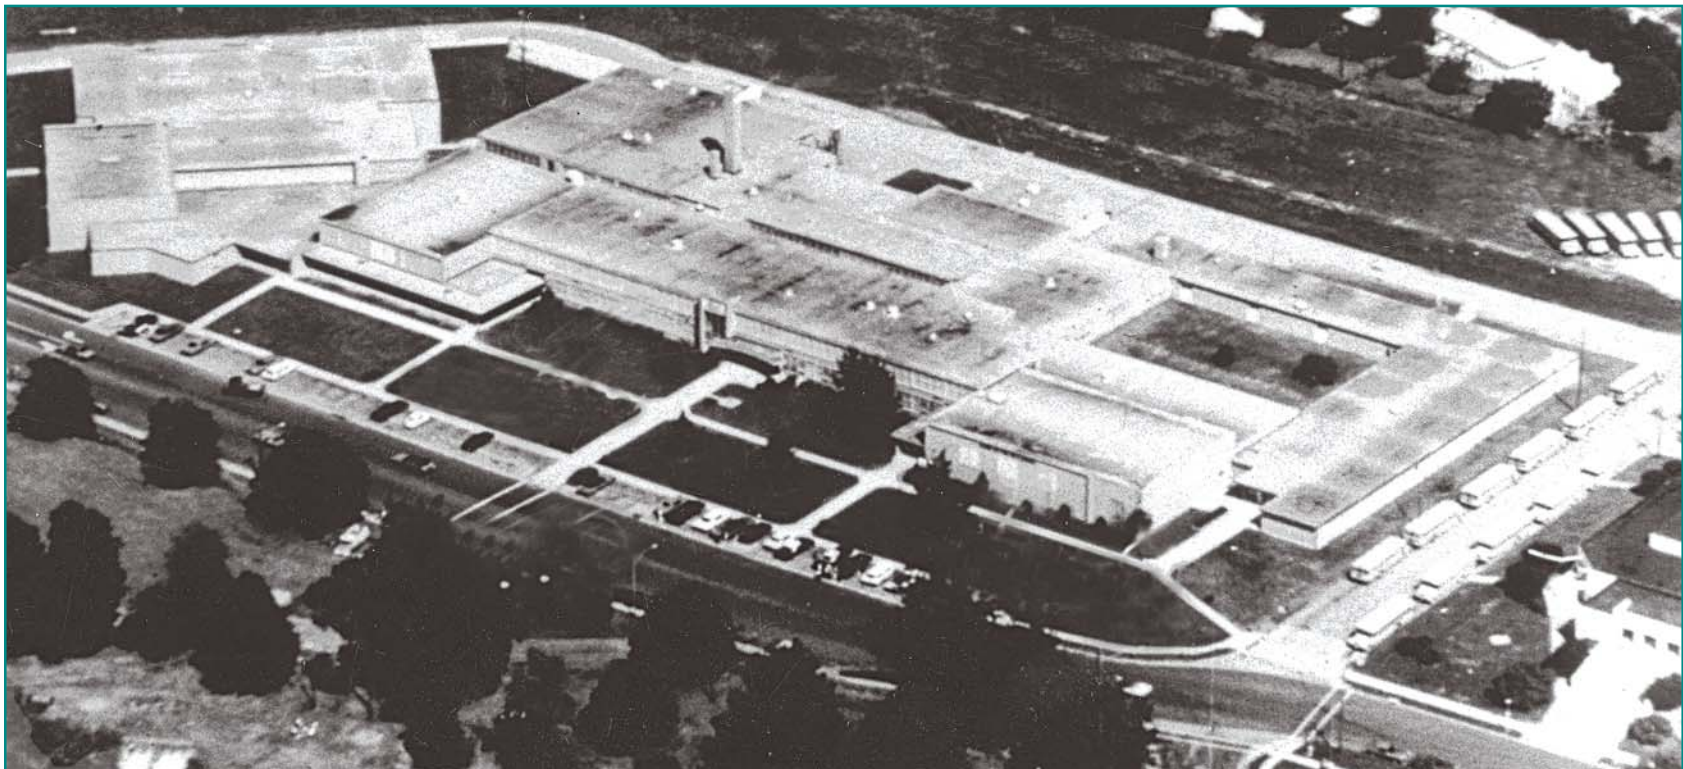
Figure 3-1 Xenia Senior High School, Xenia, Ohio.

Xenia Senior High School (Figure 3-1) was a two-story, slab-on-grade building without a basement located on the north side of Xenia, Ohio. It faced Shawnee Park to the west.

The massive tornado hit 1 hour and 45 minutes after school dismissal. It was spotted by a student who was leaving the school. She alerted drama students who were rehearsing in the auditorium. The students ran and dove for shelter in a nearby corridor.

The tornado passed directly over the school. Two school buses came to rest on the stage where the students had been rehearsing. Some of the students were treated for injuries at a nearby hospital.

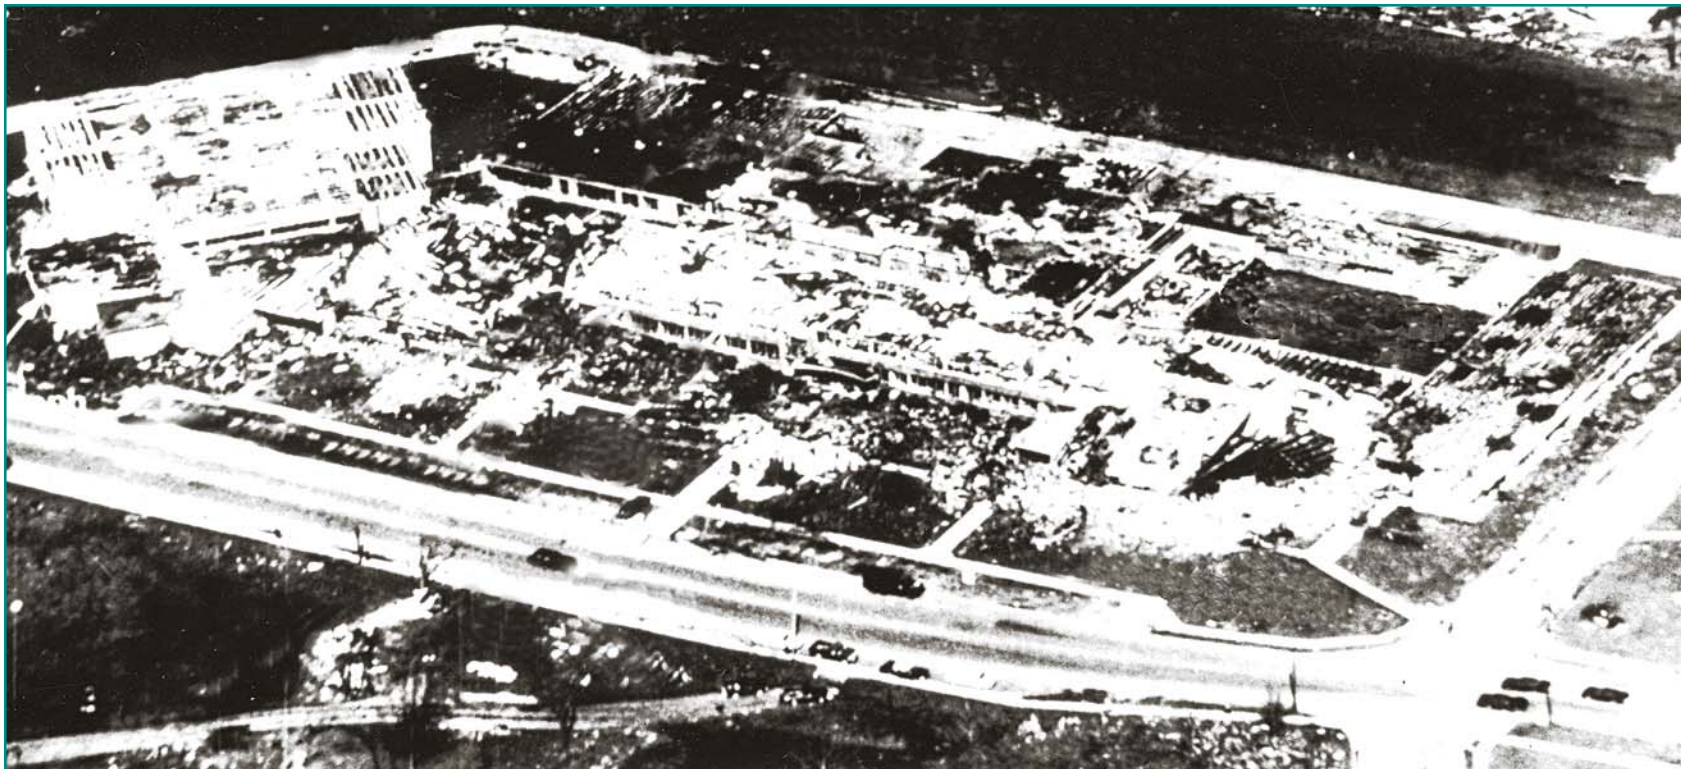
Figure 3-2 Xenia Senior High School, Xenia, Ohio.

The tornado passed directly over the school, engulfing the entire building and the adjacent fieldhouse to the south (Figure 3-2).

The enclosure walls failed on the west and south sides, allowing the winds to enter the building. The roofs collapsed over the three large spans—the auditorium, the boys' gym, and the girls' gym. The lightweight roof over the original two-story building was torn off by the extreme winds.

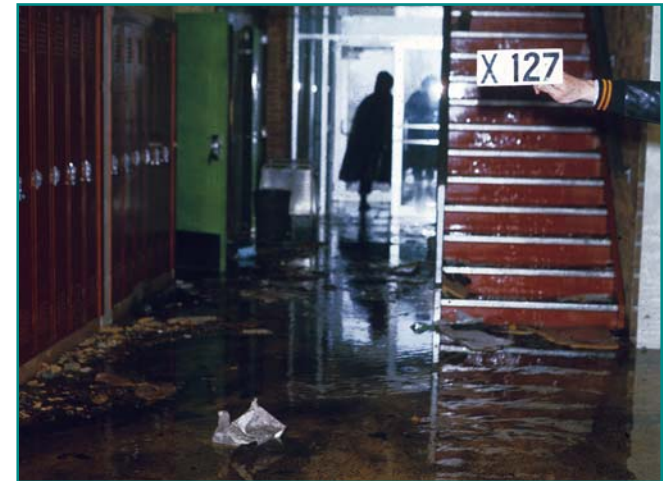
**Figure 3-3**  
*Surviving interior hallway. This is an example of the type of area that may provide refuge for building occupants during a tornado.*

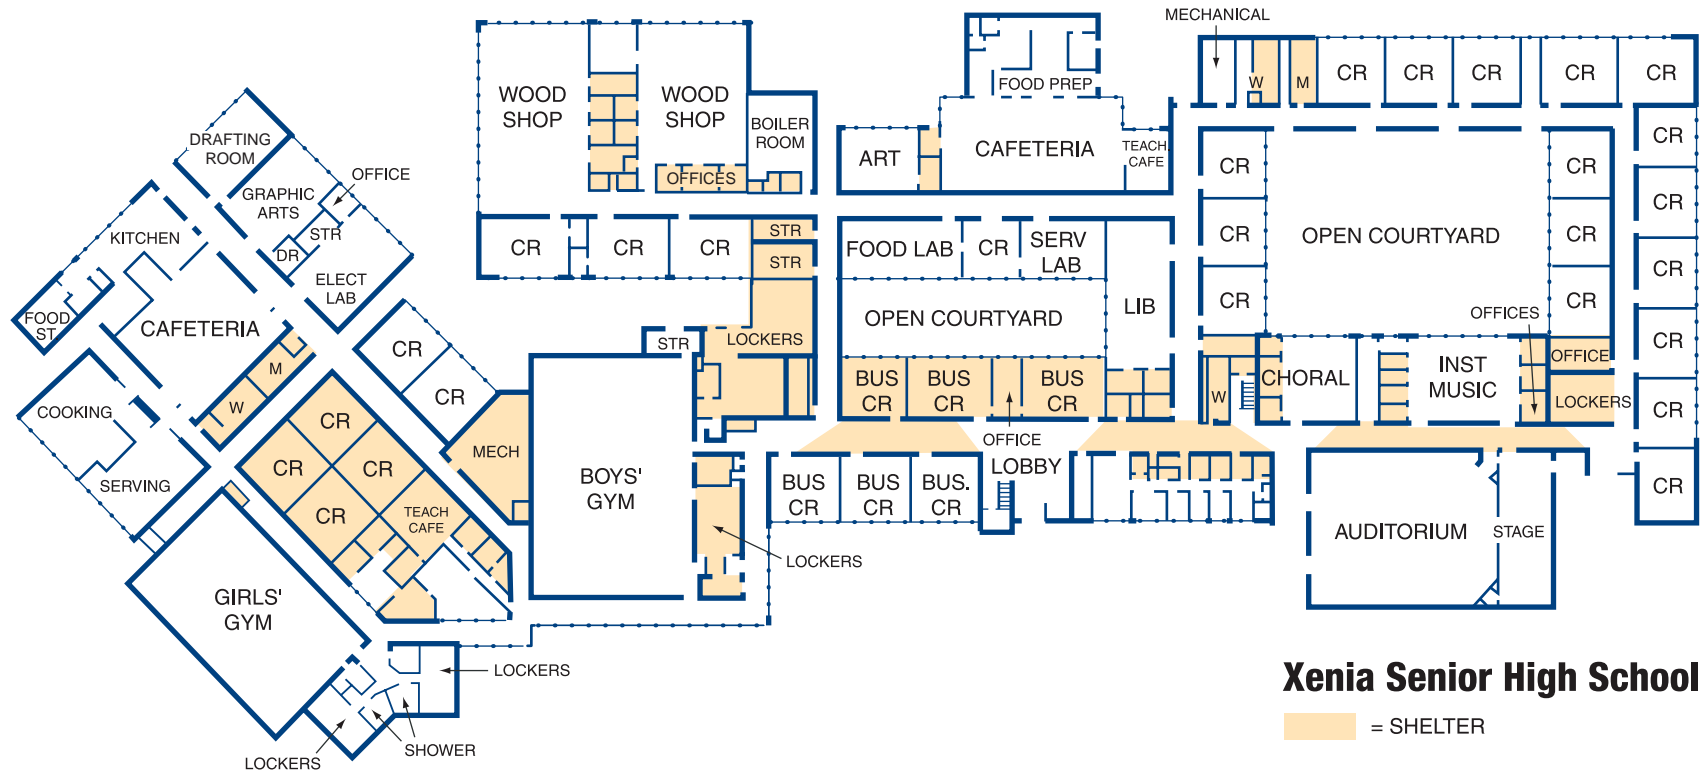
As a result of combinations of the above protective elements, extensive refuge space existed in scattered locations throughout the building (Figure 3-4).

Figure 3-4 Best available refuge areas in Xenia Senior High School.

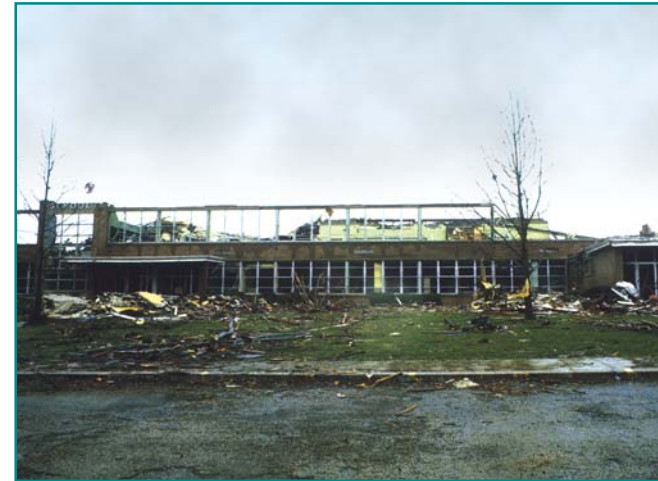
**Figure 3-5**  
***Loss of lightweight roof over the original two-story building.***

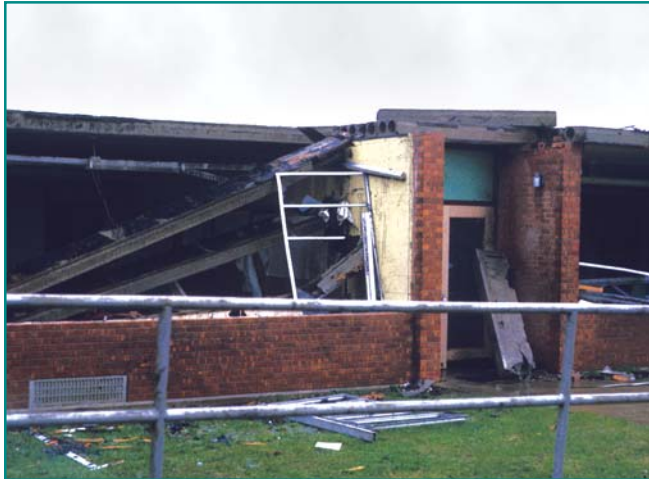
**Figure 3-6**  
**Collapsed hollow-core precast roof panels in the classroom area.**

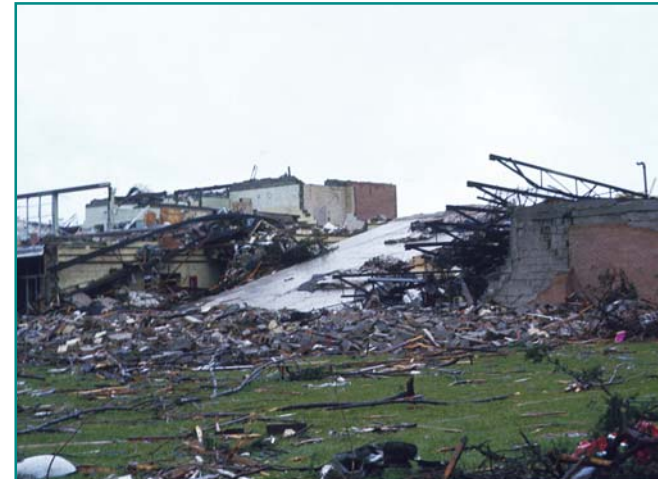
All **windows** on the west and south sides were blown into the interior. The high single-story, **loadbearing masonry walls** of the **long-span** rooms failed, allowing the roofs to fall in. The unbaffled west entrances allowed the east-west corridors to become **wind tunnels**.

**Figure 3-7**  
***Collapsed gymnasium walls and roof, where open-web roof joists were supported on unreinforced masonry walls.***

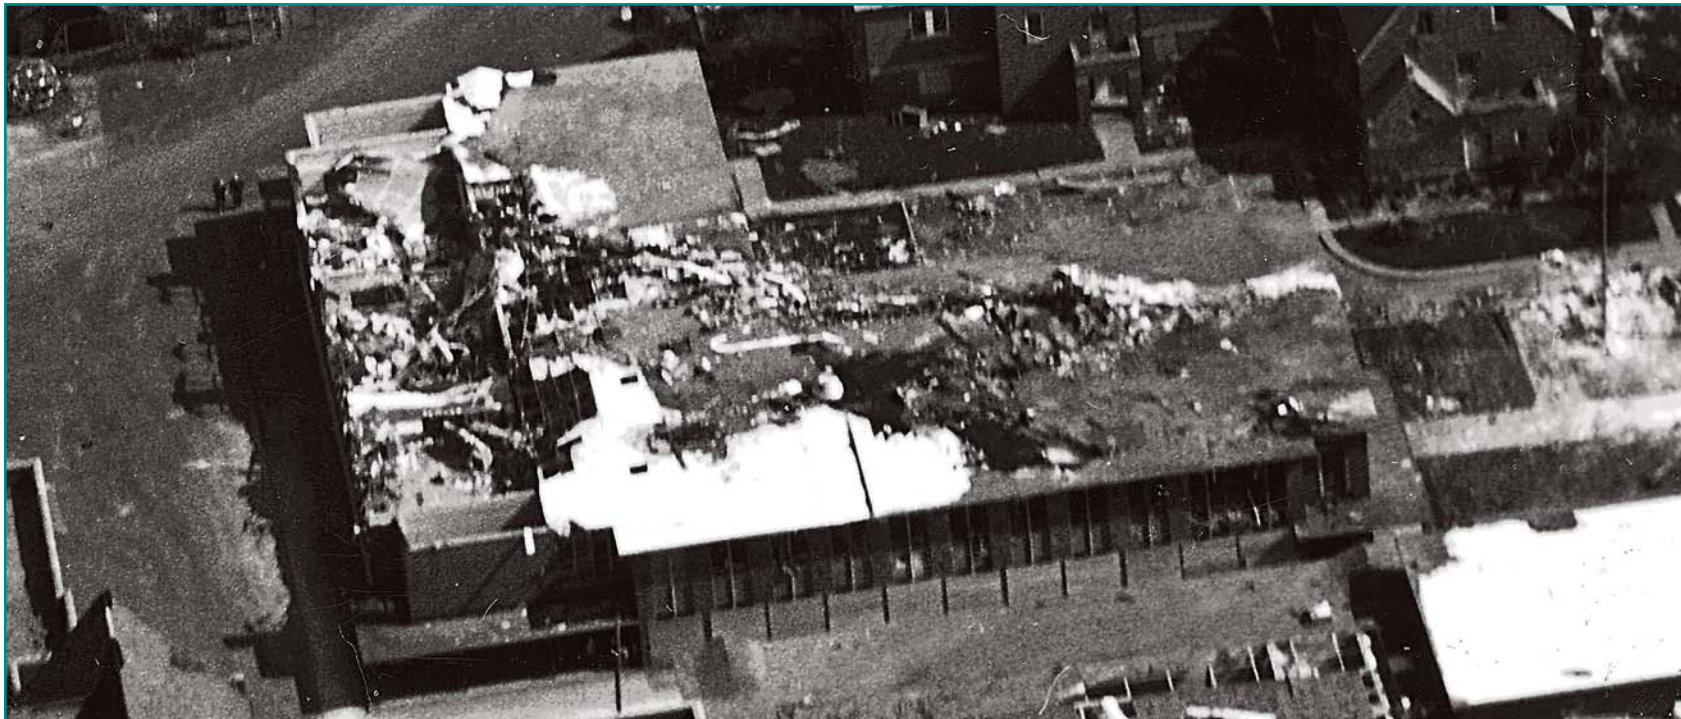
Figure 3-8 St. Augustine Elementary School, Kalamazoo, Michigan.

The tornado winds lifted part of the roof and collapsed the second-floor piers in one wing of the school building (Figures 3-8, 3-9, and 3-10). The wind and windborne debris blew in most of the windows, and windborne debris was found in the classrooms (Figure 3-11). The exterior solid-core wood doors stayed in place and kept the debris out. Wired glass windows near the exterior doors remained intact. The interior doors to the classrooms remained in place although the hinges were damaged. The school was damaged to an extent where demolition was required.

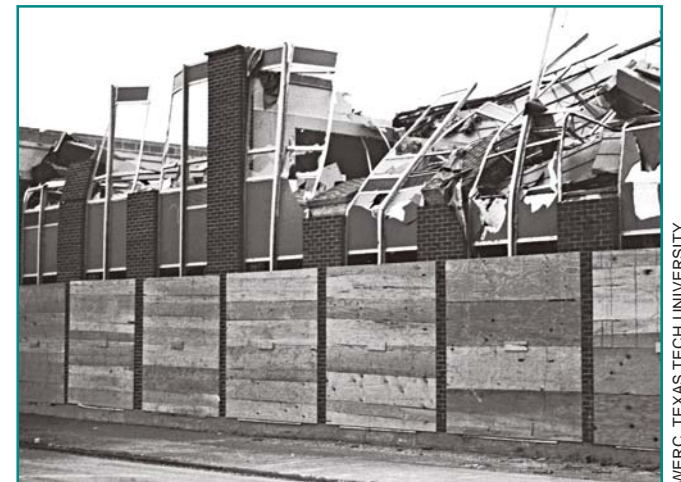
The structural system of **unreinforced masonry piers** collapsed and almost one-third of the second-floor **lightweight roof structure** was lifted. Roof removal occurred over the classrooms as well as over the corridor. Most of the **skylights** in the corridors were removed by wind or broken by windborne debris. Almost all the **windows** on both floors were broken. Windborne debris and broken glass were found in the classrooms.

**Figure 3-9**  
*Collapsed second floor of St. Augustine Elementary School building.*

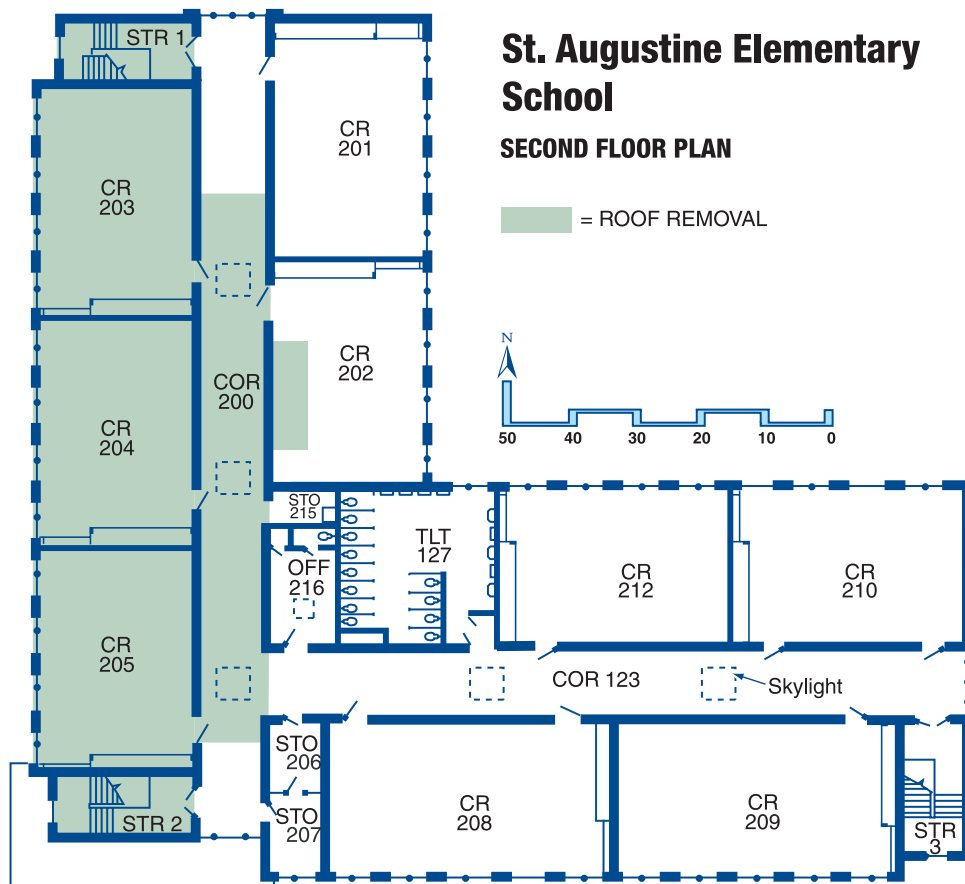
**Figure 3-10**  
*Floor plan of second floor of St. Augustine Elementary School showing locations of roof removal.*

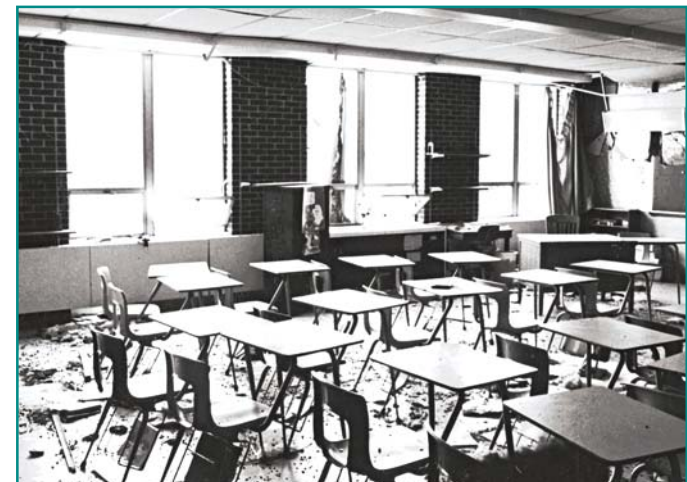
**Figure 3-11**  
*Broken windows and debris in classroom of St. Augustine Elementary School building.*

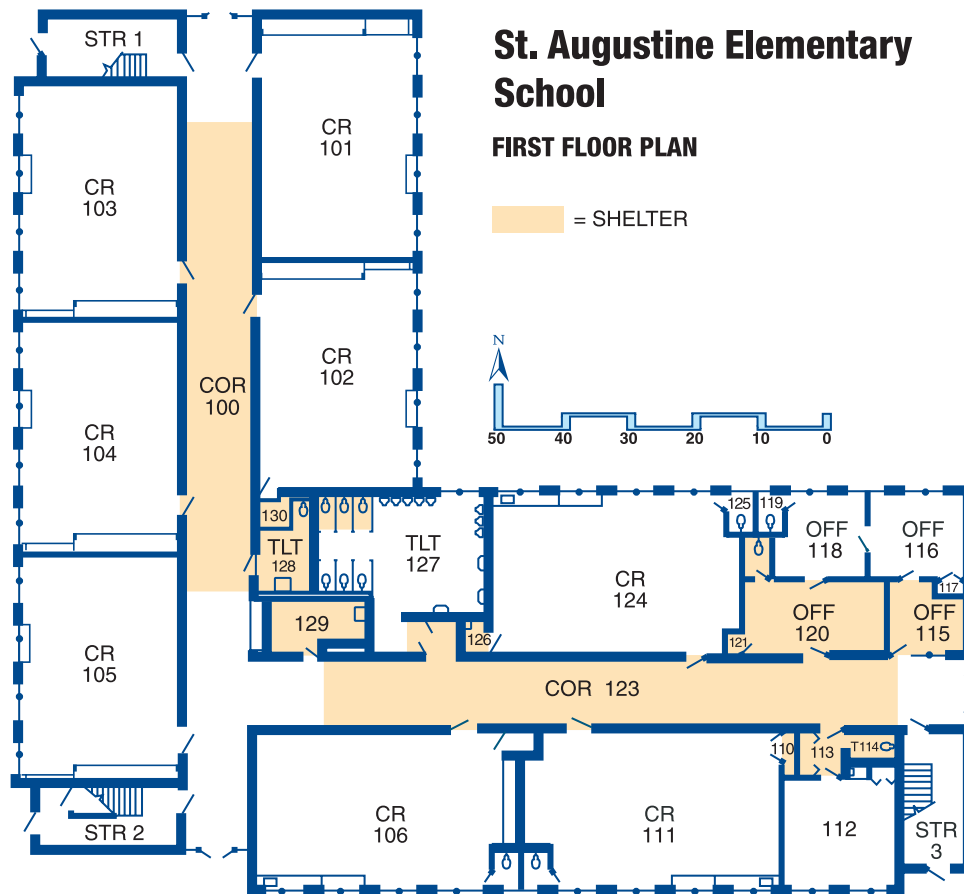
The structural system of the first floor remained intact. The exterior **solid-core wood doors** stayed in place and kept the debris out. The interior walls and doors were able to prevent debris from entering the corridors. The corridors, offices, and toilet areas on the first floor, which had two or more walls to the exterior, would have protected the occupants from serious injury (Figure 3-12).

**Figure 3-12**  
*Best available refuge areas in the St. Augustine Elementary School building.*

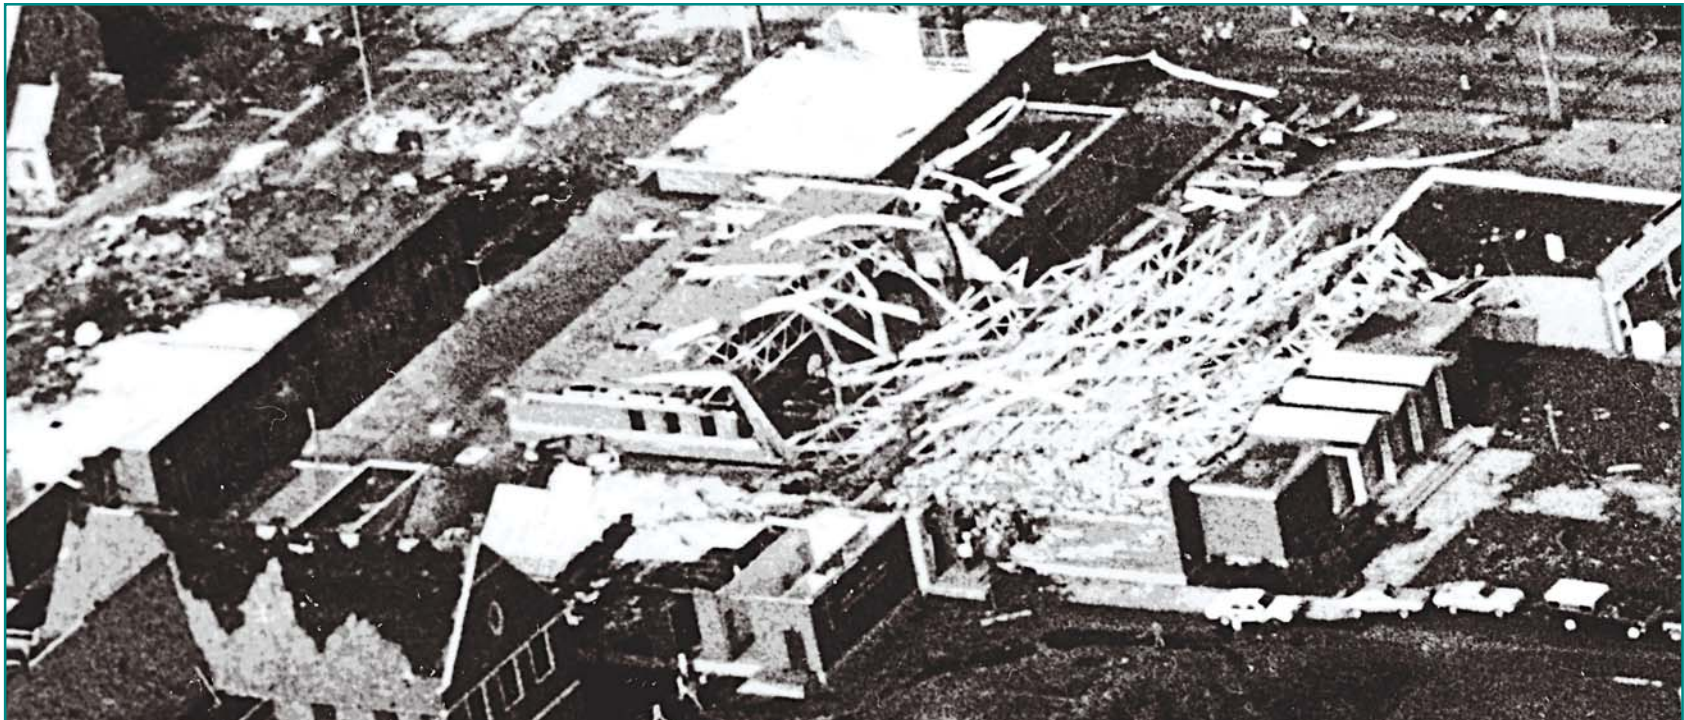
Figure 3-13 St. Augustine Elementary School Gymnasium, Kalamazoo, Michigan.

The building was destroyed (Figures 3-13 and 3-14). The loadbearing west wall collapsed inward, and the east wall fell outward. The roof fell in the building when the walls collapsed.

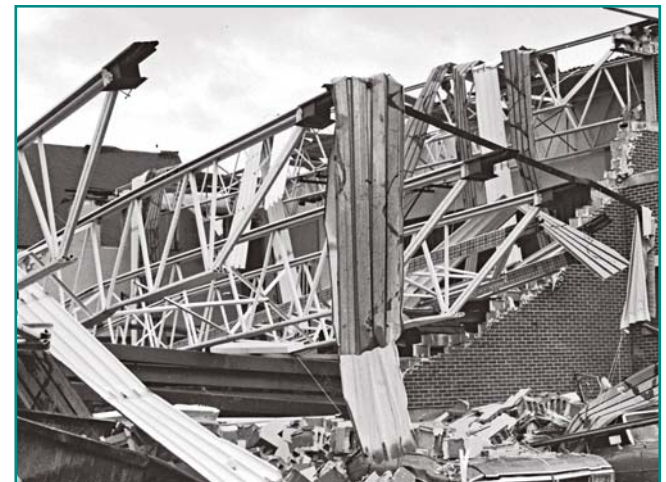
**Slender unreinforced masonry walls** and **long-span** roof structure.

**Figure 3-14**  
***Collapsed St. Augustine Elementary School***  
***Gymnasium building.***

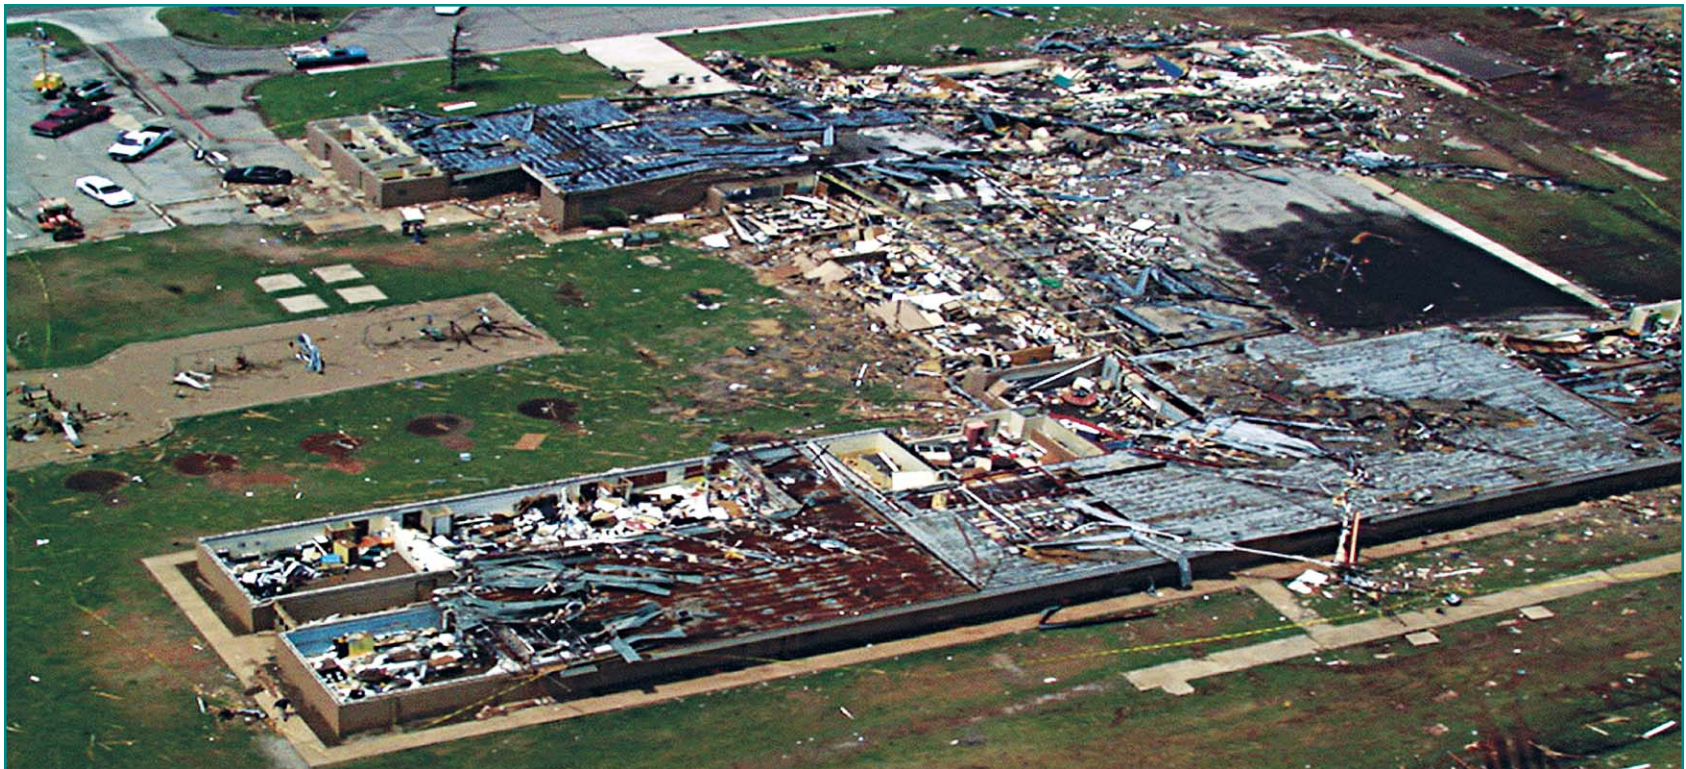
Figure 3-15 Kelly Elementary School, Moore, Oklahoma.

The tornado hit after school hours and passed just to the north of the site. Damage to the school building was both severe and extensive (Figure 3-15). As discussed in the Lessons Learned section in this case study, the remaining structure was demolished and the school was rebuilt. The new school includes structural elements designed to provide increased wind resistance.

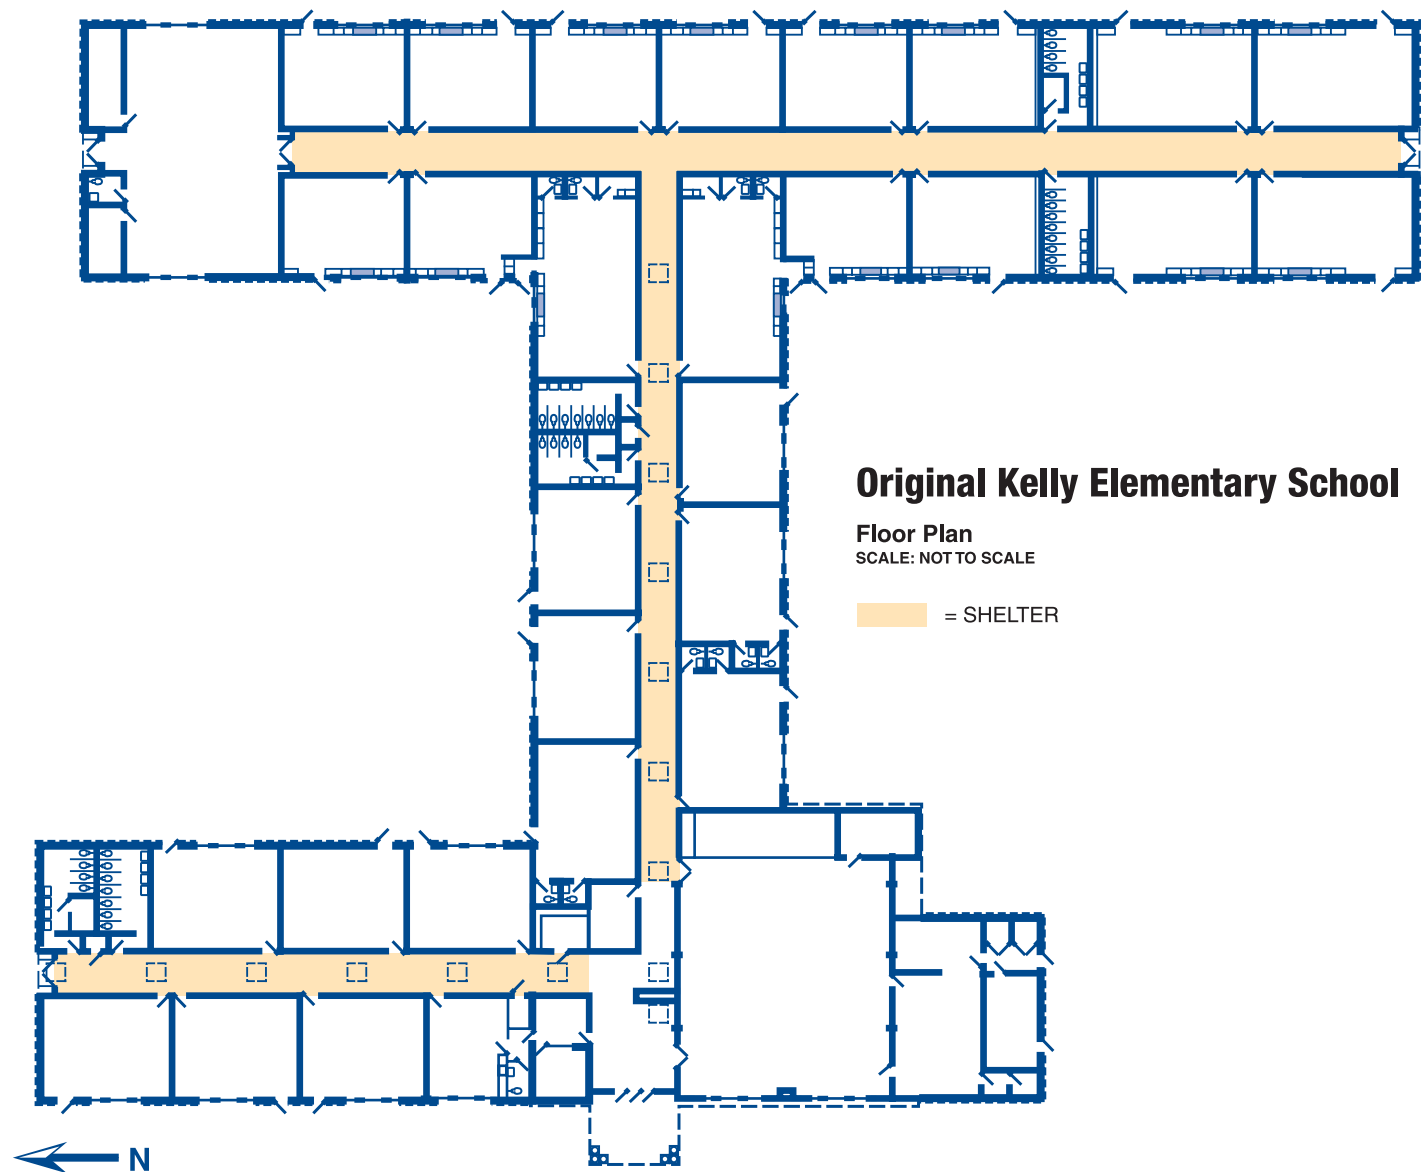
Hall corridors were the designated areas of refuge (see Figure 3-16). The corridor walls were of lightweight steel frame with masonry infill. The infill extended to a height of approximately 7 feet. Above this height were clerestory windows that extended to the tops of the walls. Had the halls been occupied during the tornado, many injuries and deaths would have occurred (see Figure 3-20, later in this chapter).

Figure 3-16 Designated refuge areas in the original Kelly Elementary School.

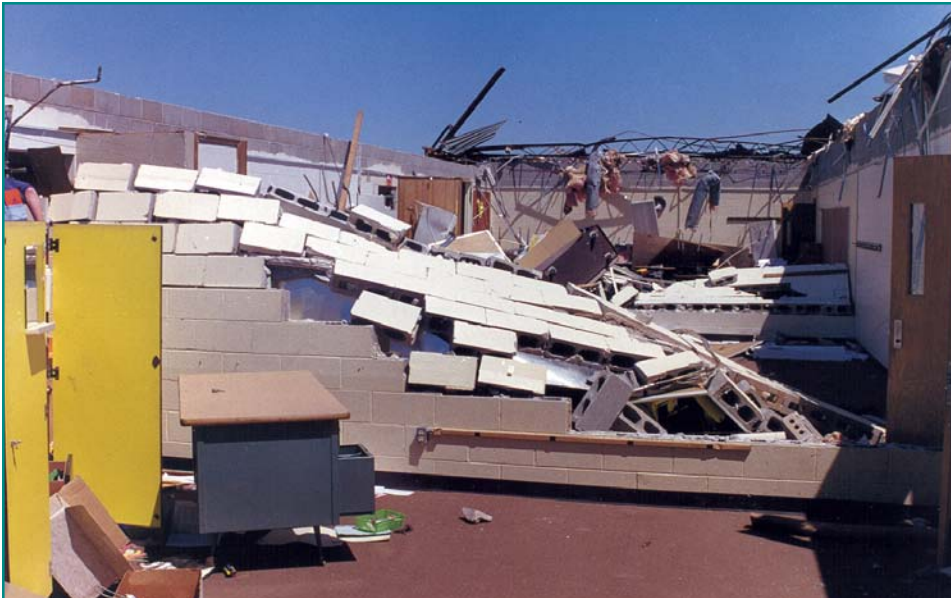
Unreinforced masonry walls failed when the roof system was lifted or removed by tornado winds (Figures 3-17, 3-18, and 3-19). Figures 3-17 and 3-19 show failed interior and exterior walls, respectively. Figure 3-18 shows the separation of the reinforced bond beam (indicated by circles) from the upper part of a corridor wall. The inclusion of clerestory windows in some corridor walls contributed to their failure under loads imposed by tornado winds (Figure 3-20).

**Figure 3-17**  
*Interior and exterior unreinforced masonry walls were damaged when reinforced bond beams failed.*

**Unreinforced masonry** walls failed when the reinforced bond beams at the tops of the walls failed.

The improvements discussed here are designed to prevent the types of damage to interior corridor walls and roofs shown previously in Figures 3-17, 3-18, 3-20, and 3-21. The reconstruction of the Kelly Elementary School is a good example of how refuge areas can be incorporated into new construction.

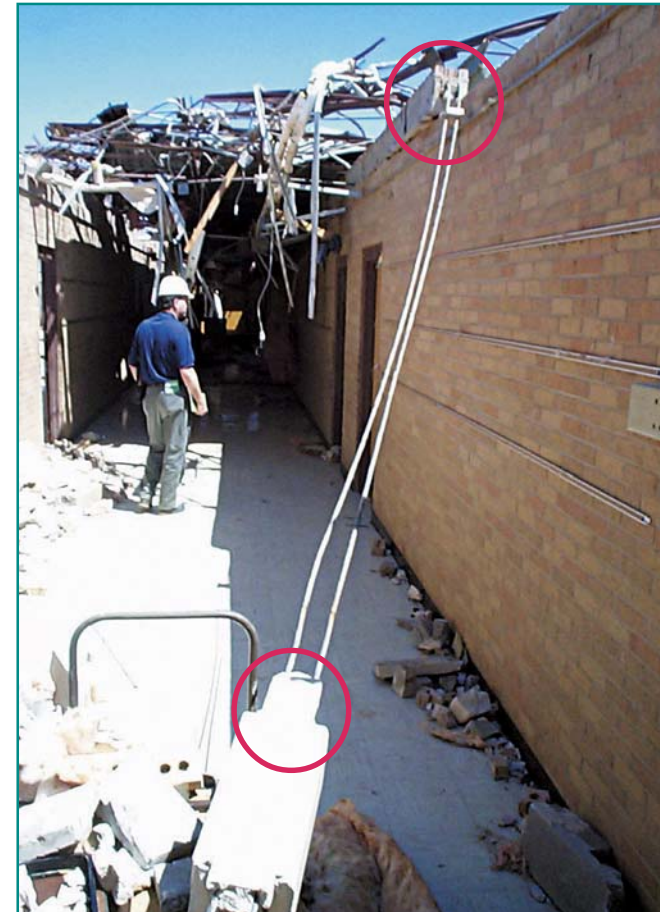
**Figure 3-18**  
*Corridor area. Separation of reinforced bond beam (indicated by circles) from supporting wall.*

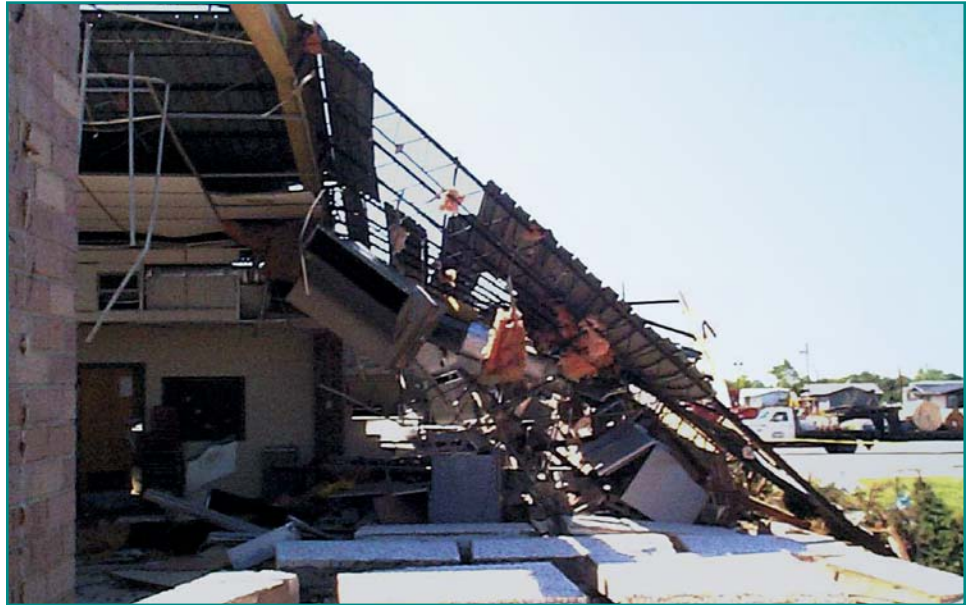
**Figure 3-19**

*Collapsed roof structure and exterior wall.*

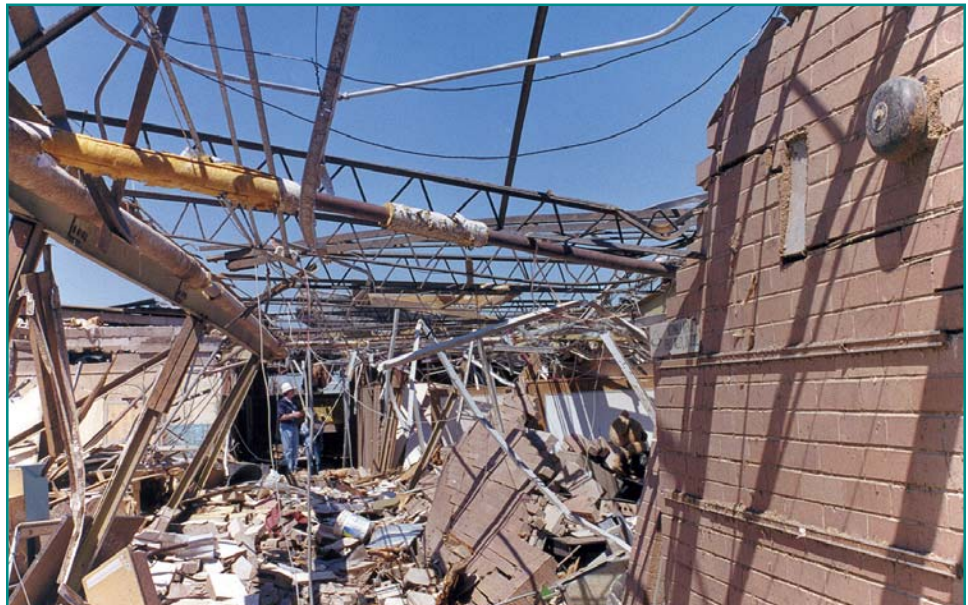
**Figure 3-20**

*Failed interior corridor walls. These walls consisted of unreinforced brick masonry infill between steel-frame members. The brick masonry extended to a height of approximately 7 feet. Clerestory windows extended from the top of the masonry to the tops of the walls.*

Walls with **clerestory windows**, such as the corridor walls of the designated areas of refuge, have limited capacity to resist lateral forces.

Figure 3-26 is a typical cross-section of the bottom of a safe area wall. Note that the wall is securely tied to the floor slab with L-shaped reinforcing bars placed 24 inches on center. As shown in Figures 3-23 and 3-24, the corridor walls do not include the clerestory windows that increased the vulnerability of the corridor walls in the original school building.

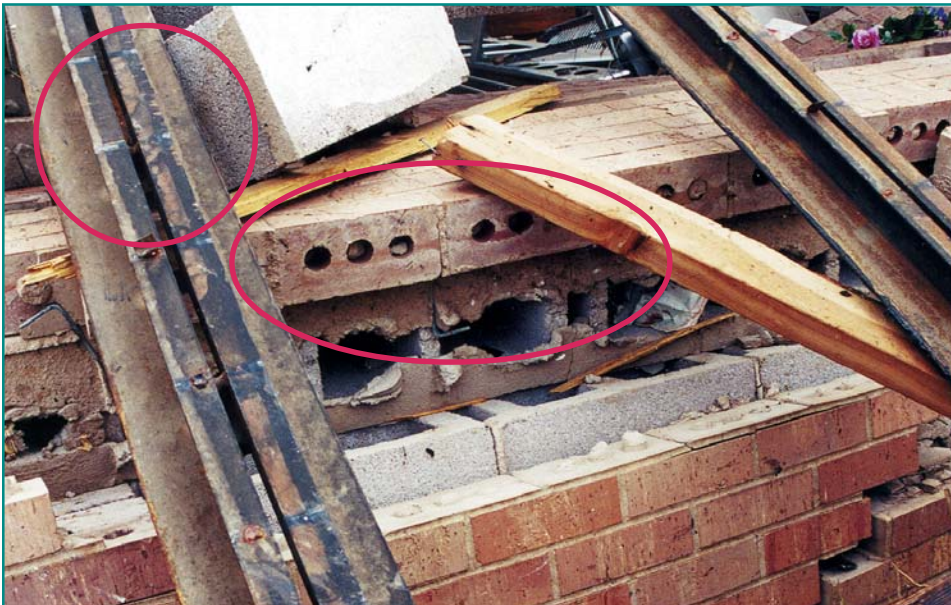
Inspection of the roof damage revealed that the roof decking failed at the points where it was welded to the tops of the steel trusses. Although the spacing of the welds appeared to be consistent with standard practice, the welds were not strong enough to resist the wind uplift forces (Figure 3-21).

**Figure 3-21**  
*Failed roof structure showing broken welds between metal roof deck and tops of joists (upper circle) and lack of vertical reinforcement (bottom circle).*

**Welds** between the roof decking at the tops of the metal joists failed because they were **not strong enough to resist the uplift**.

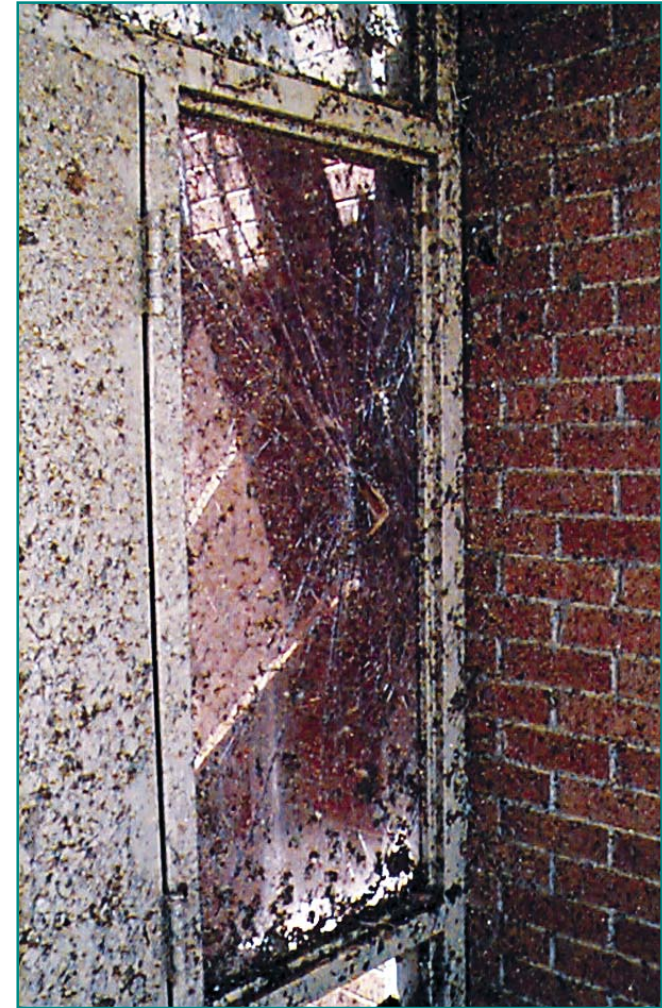
Damage was also caused by the impact of windborne missiles. Figure 2-3, in Chapter 2, shows a steel door that appeared to have been opened by the impact of a heavy object. This door led into an area where the roof was missing. The opening created by this breached door may have allowed wind to enter the building and create internal pressure that increased the load on the building envelope. Figure 3-22 shows damage to a laminated glass window hit by a table.

**Figure 3-22**  
*Impact performance of laminated glass. The corner of a table penetrated this laminated glass window, but the glass remained in its frame.*

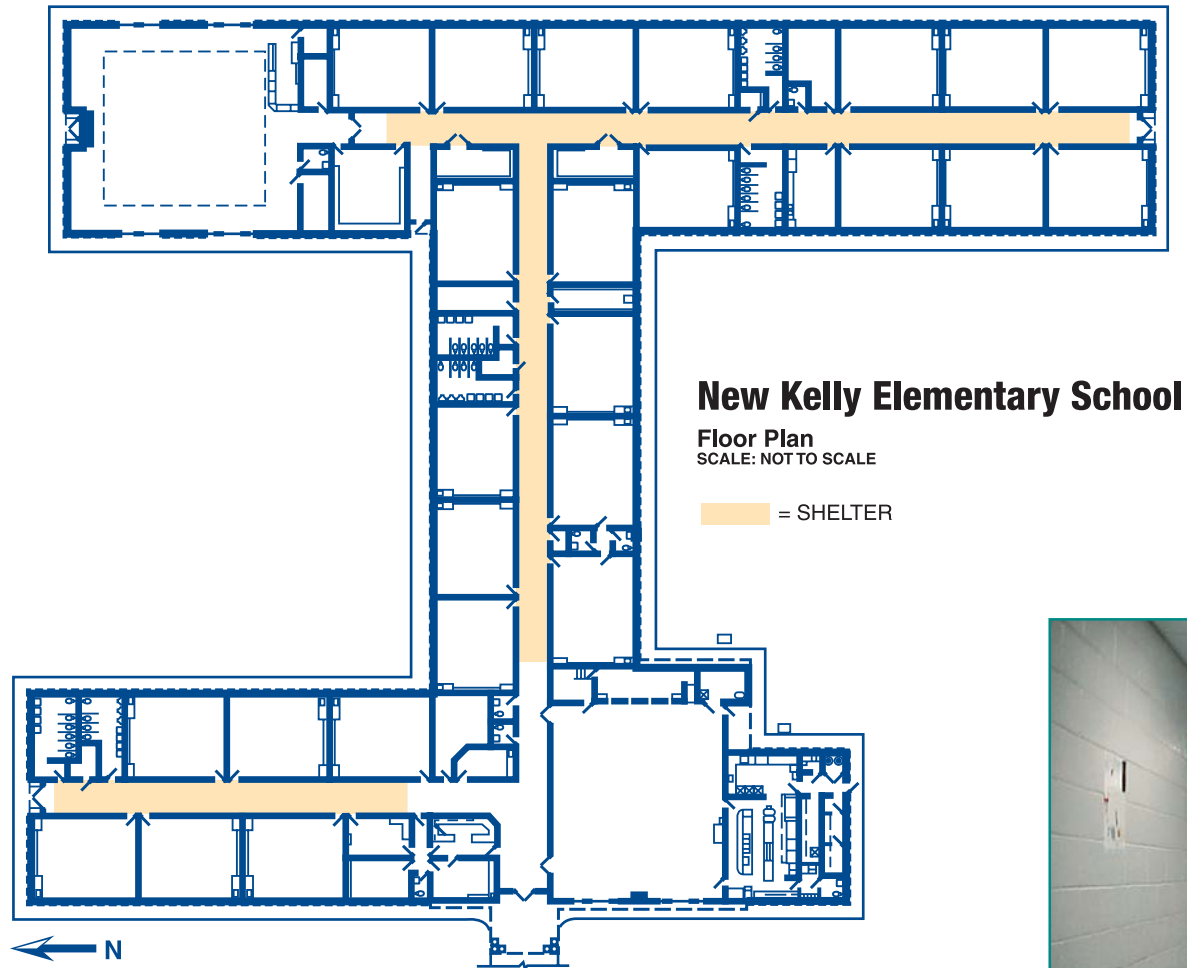
**Figure 3-23**  
*Designated refuge areas in the reconstructed Kelly Elementary School.*

Because the damage to Kelly Elementary School was so great, the school was demolished and completely rebuilt. The new building, although constructed on the same footprint, incorporated several structural improvements specifically designed to provide improved resistance to extreme winds and create refuge areas for the school's occupants. As in the original building, the central corridors of the three wings are the designated refuge areas (Figures 3-23 and 3-24).

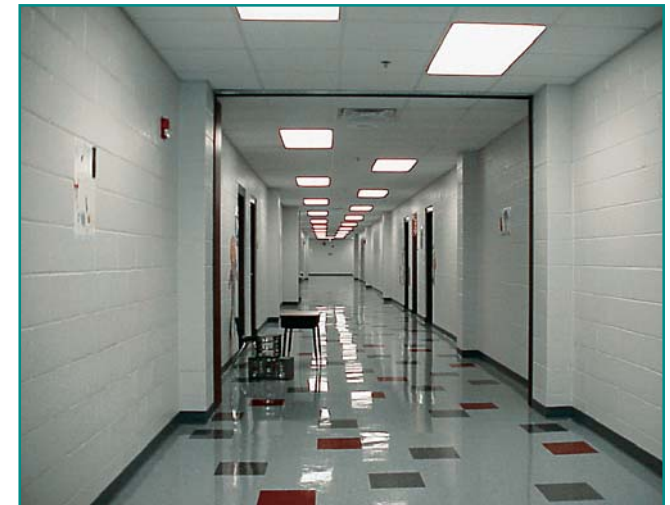
**Figure 3-24**  
*Corridor (designated safe area) in reconstructed Kelly Elementary School.*

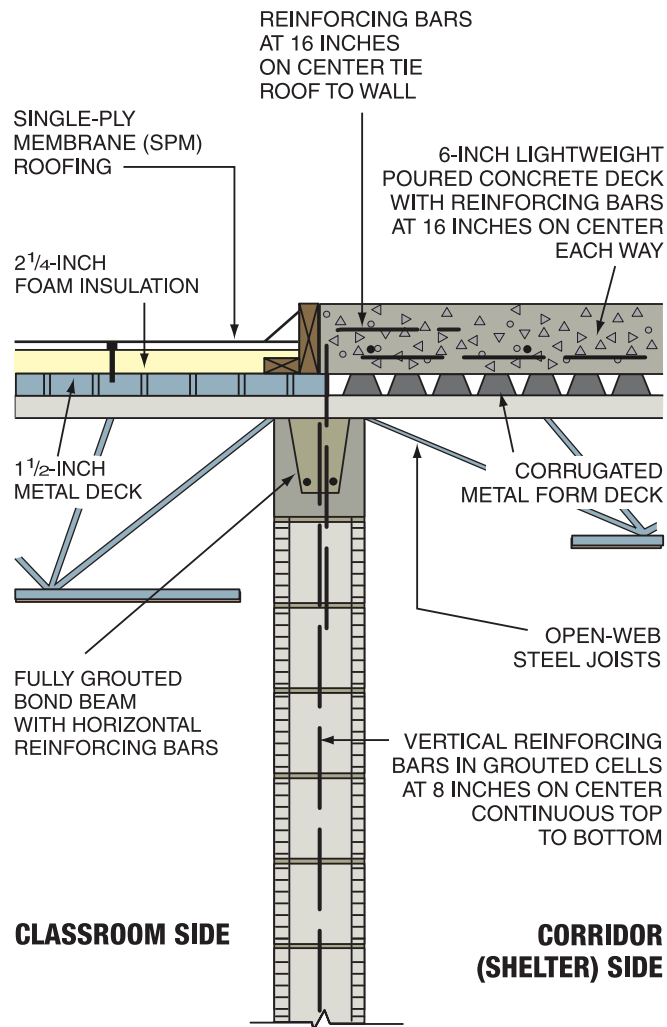
**Figure 3-25**  
Typical cross-section of top of safe area wall in the reconstructed Kelly Elementary School.

The creation of refuge areas in the new school involved, among other improvements, the design and construction of stronger loadbearing walls, roofs, roof-to-wall connections, and wall-to-foundation connections. Figure 3-25 is a typical cross-section of the top of a safe area (corridor) wall in the new school. As shown in this figure, the wall is constructed of reinforced concrete masonry. Note the continuous, closely spaced (8 inches on center) vertical reinforcement bars, fully grouted block cells, 6-inch-thick reinforced concrete

roof slab, and strong connection between the roof slab and wall. The new ceilings over the corridors are constructed of poured reinforced concrete, which will provide nearly ultimate resistance to winds and damaging missiles.

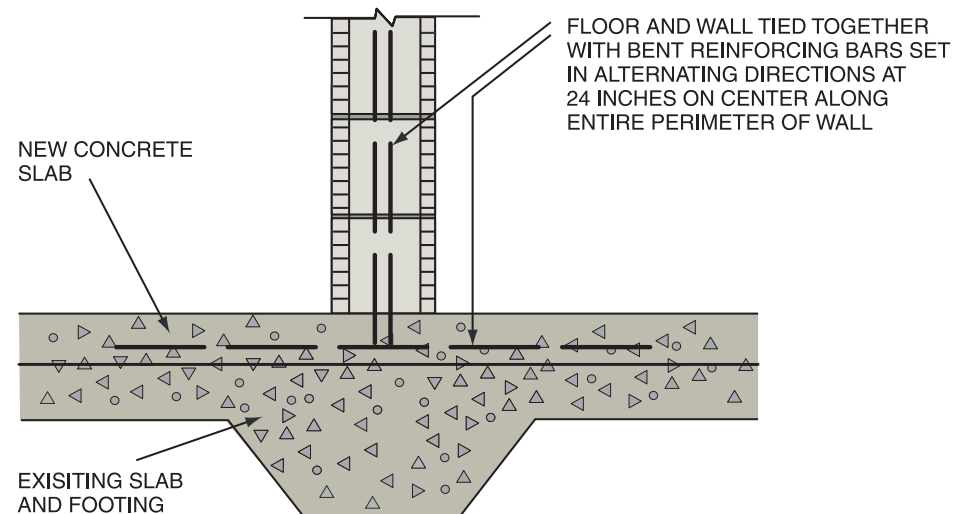
**Figure 3-26**  
Typical cross-section of bottom of safe area wall in the reconstructed Kelly Elementary School.
